Trouble-shooting program

1. Special features

Special features, test specifications
Opel

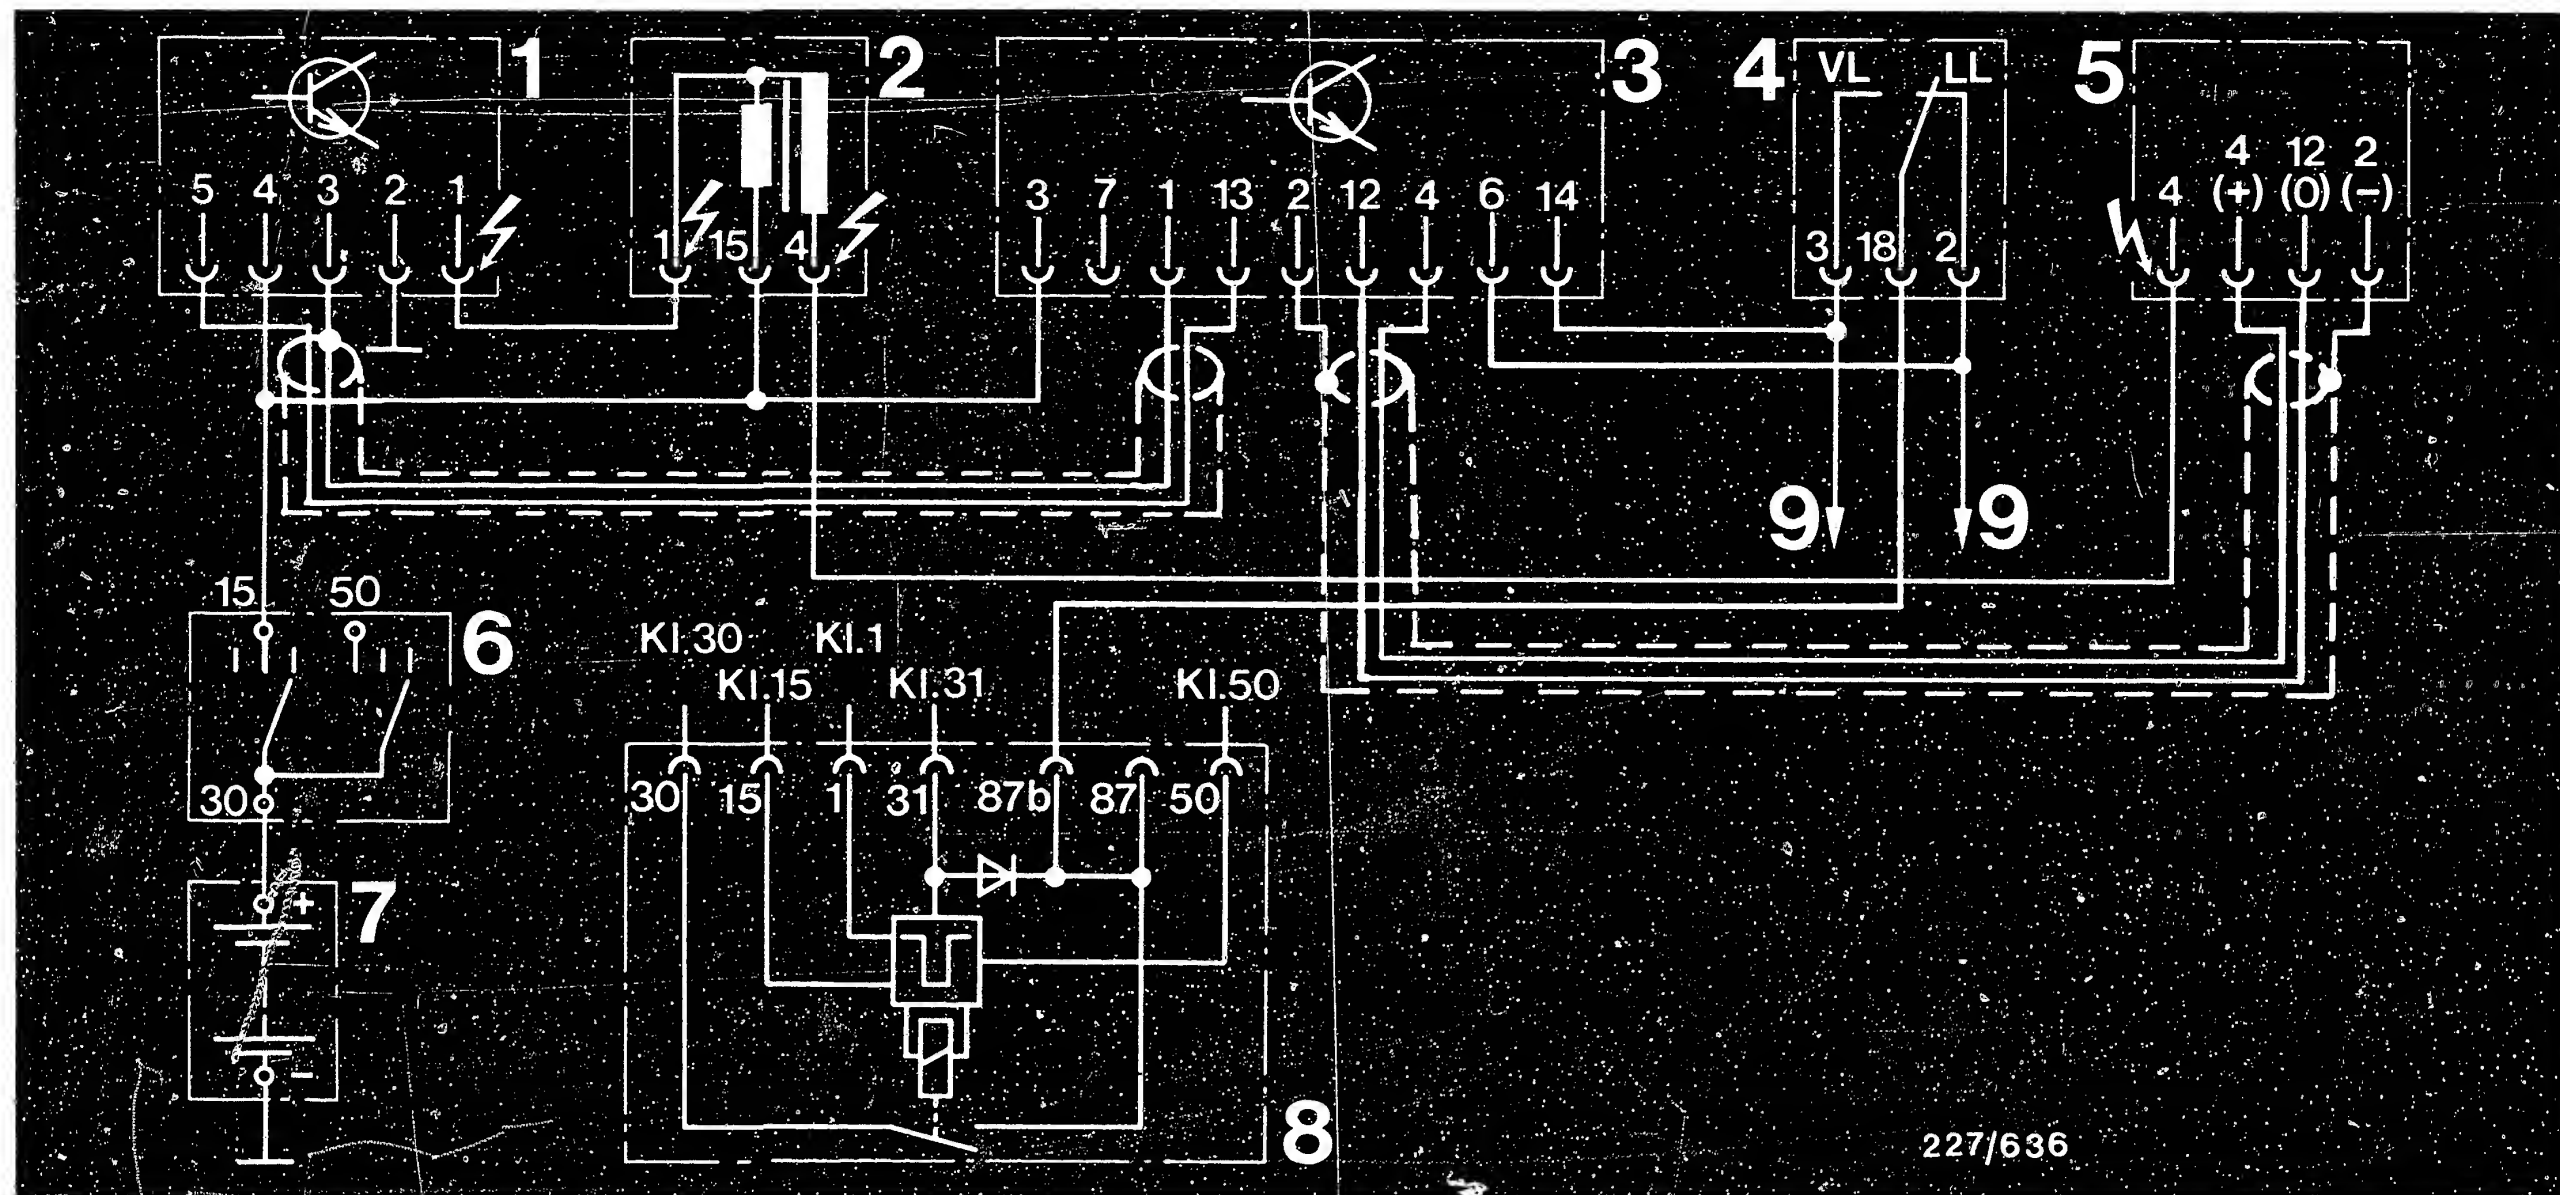
High-voltage arrows:
Caution, 400V...25 kV

- 1 = Trigger box
- 2 = Ignition coil
- 3 = Spark advance mechanism

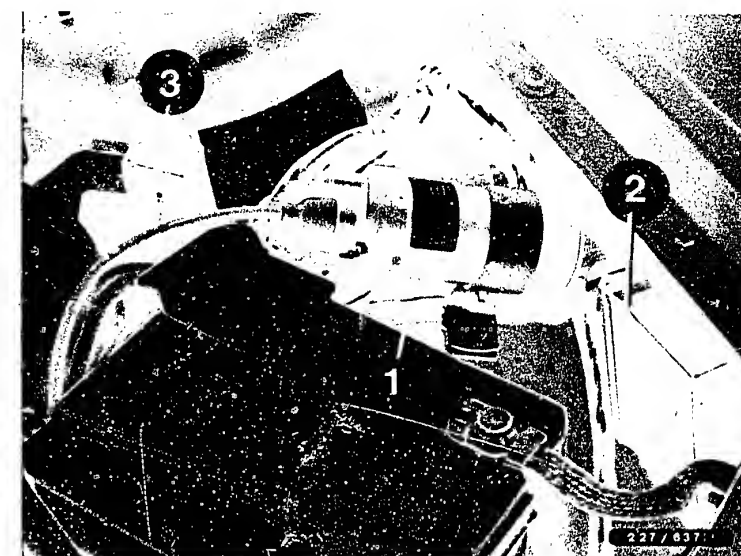
Press the detent for the spark advance mechanism plug in the direction of the arrow, and then turn the plug in the direction of the arrow. See lower illustration.

The L-Jetronic control relay is located next to the ignition coil. See upper illustration.

- 1 = trigger box
- 2 = spark advance mechanism
- 3 = L-Jetronic control relay

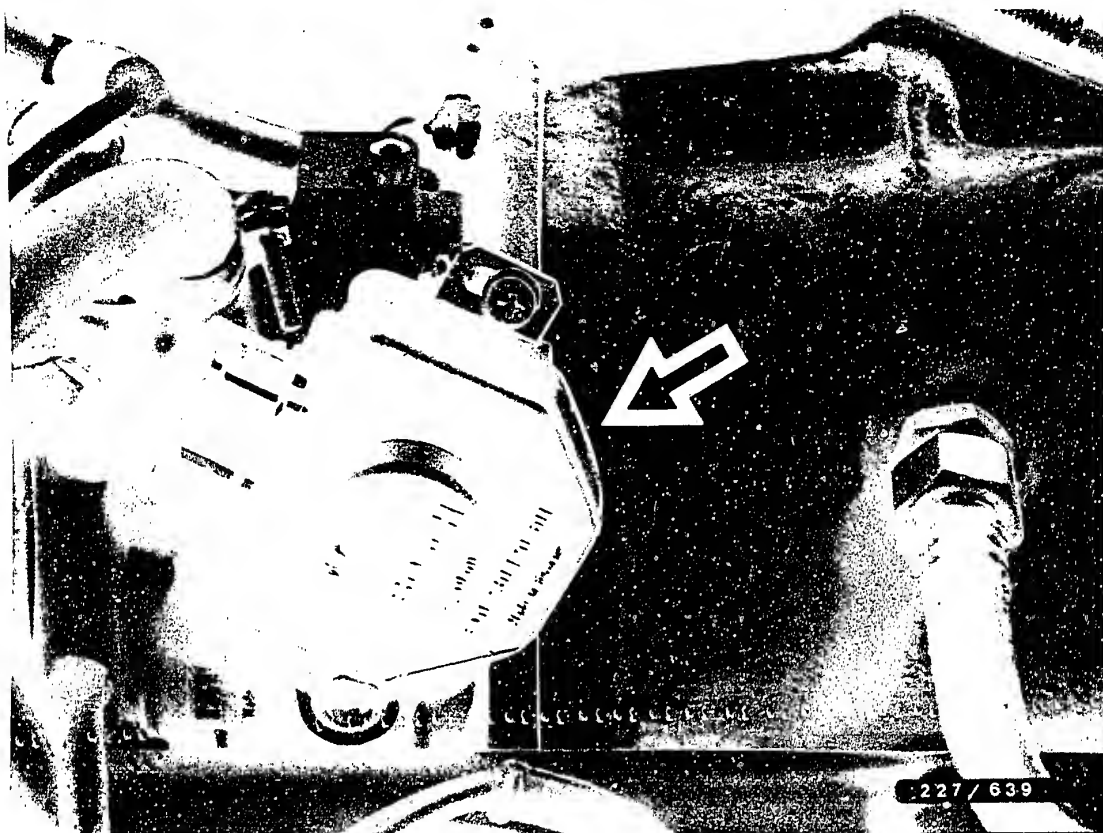
Arrow = Throttle-valve switch

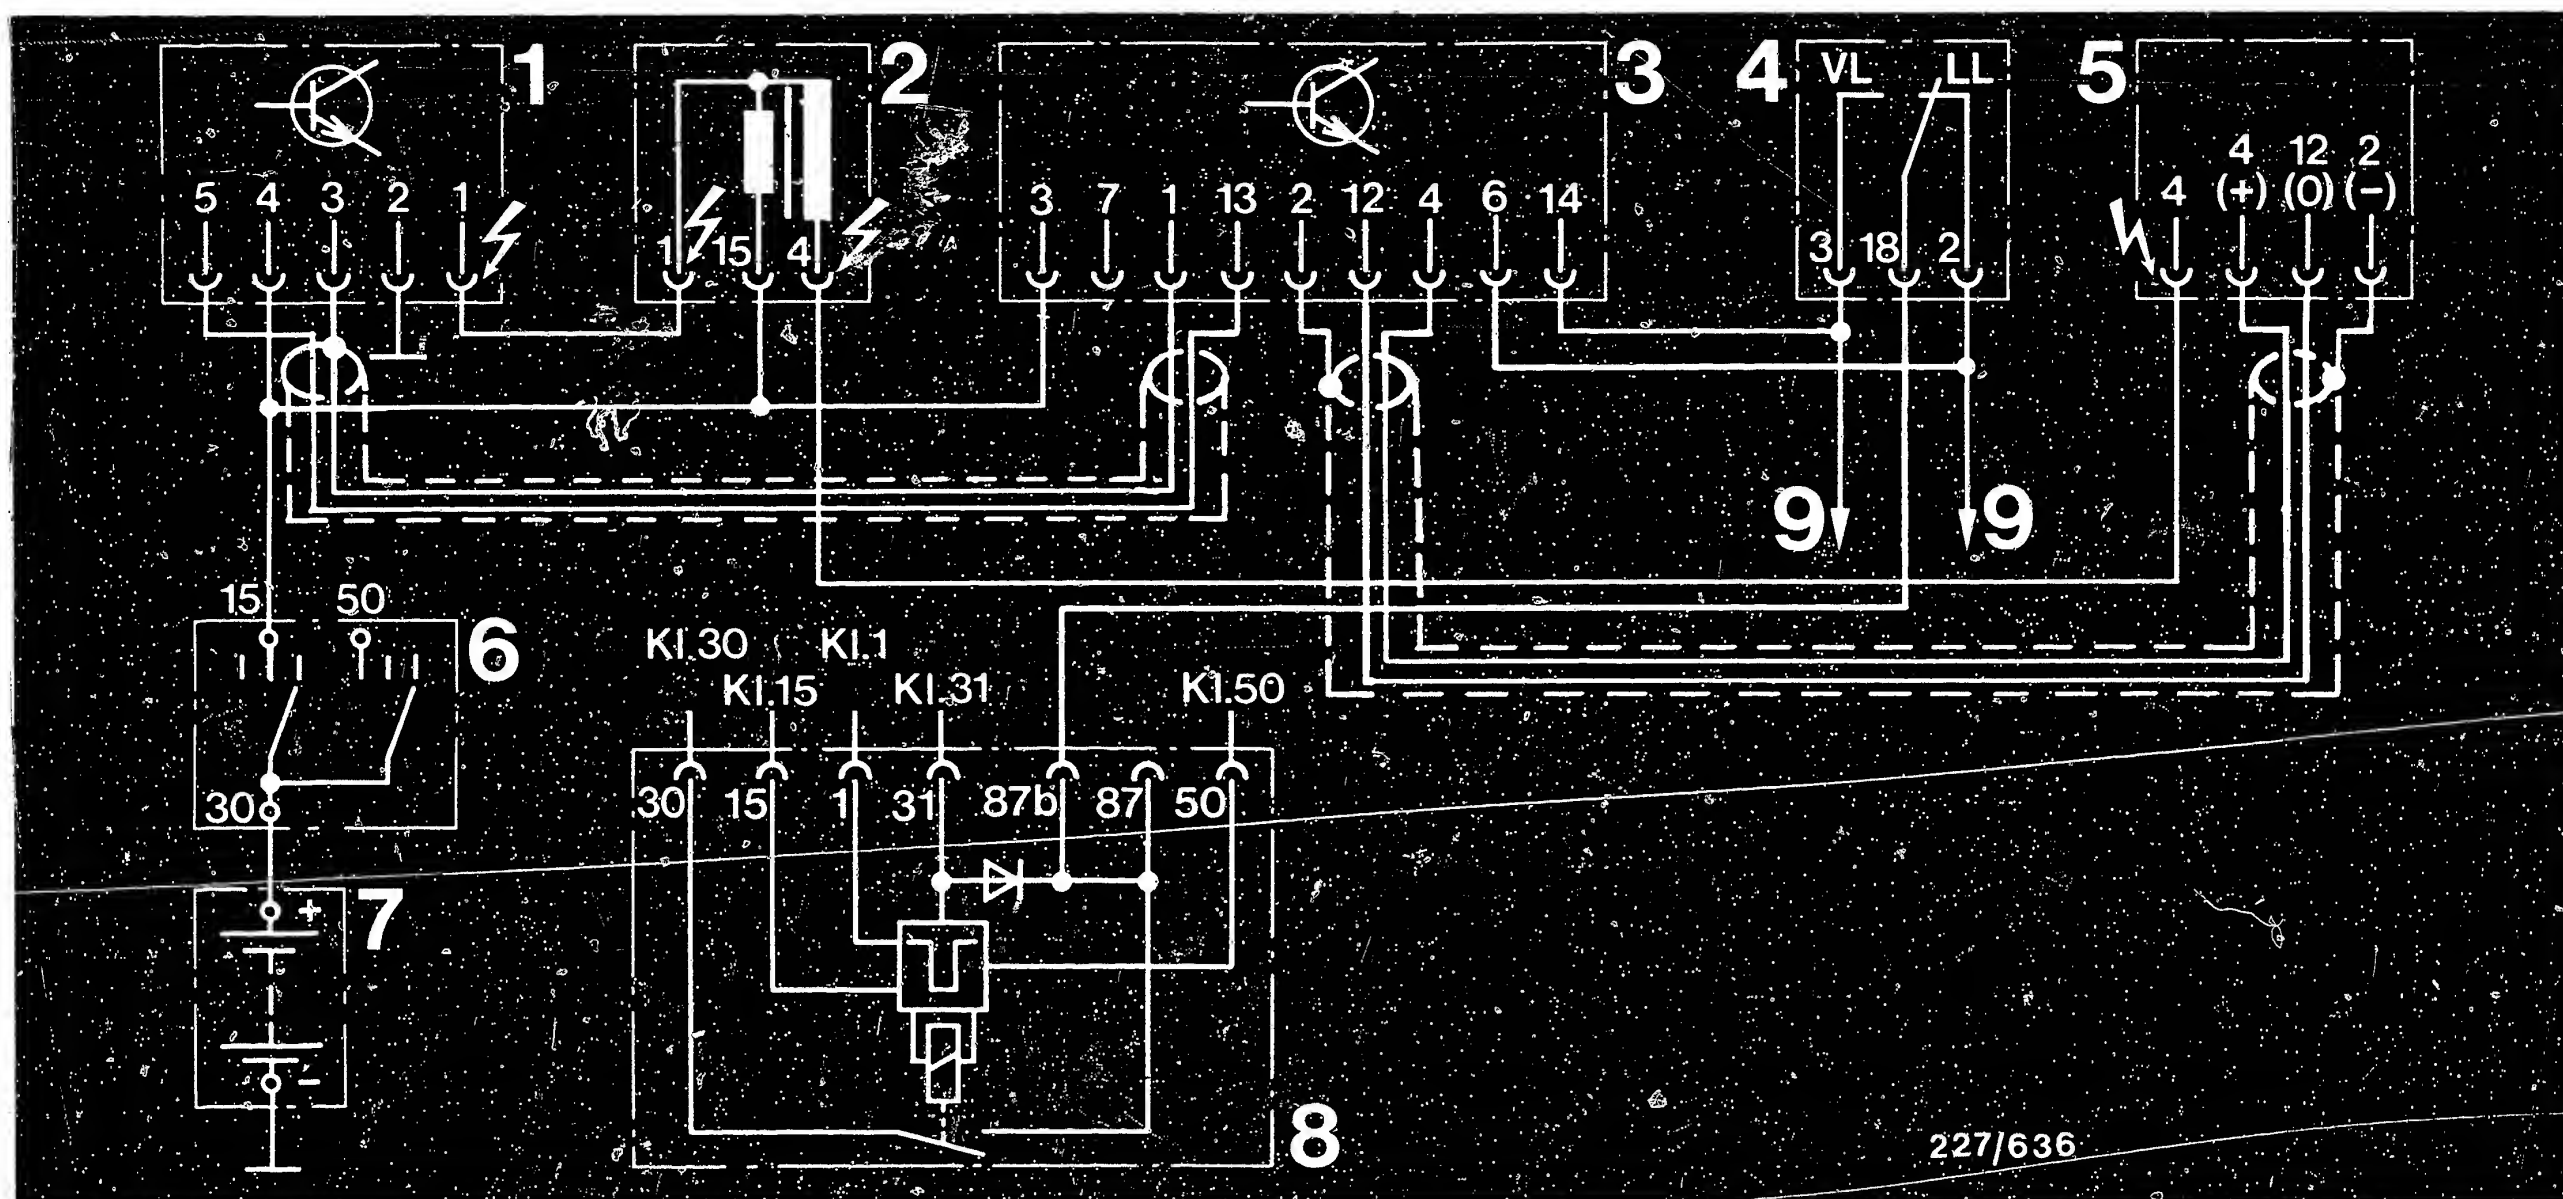
High-voltage arrows:
Caution, 400V...25 kV

1 = Trigger box
2 = Ignition coil
3 = Spark advance mechanism

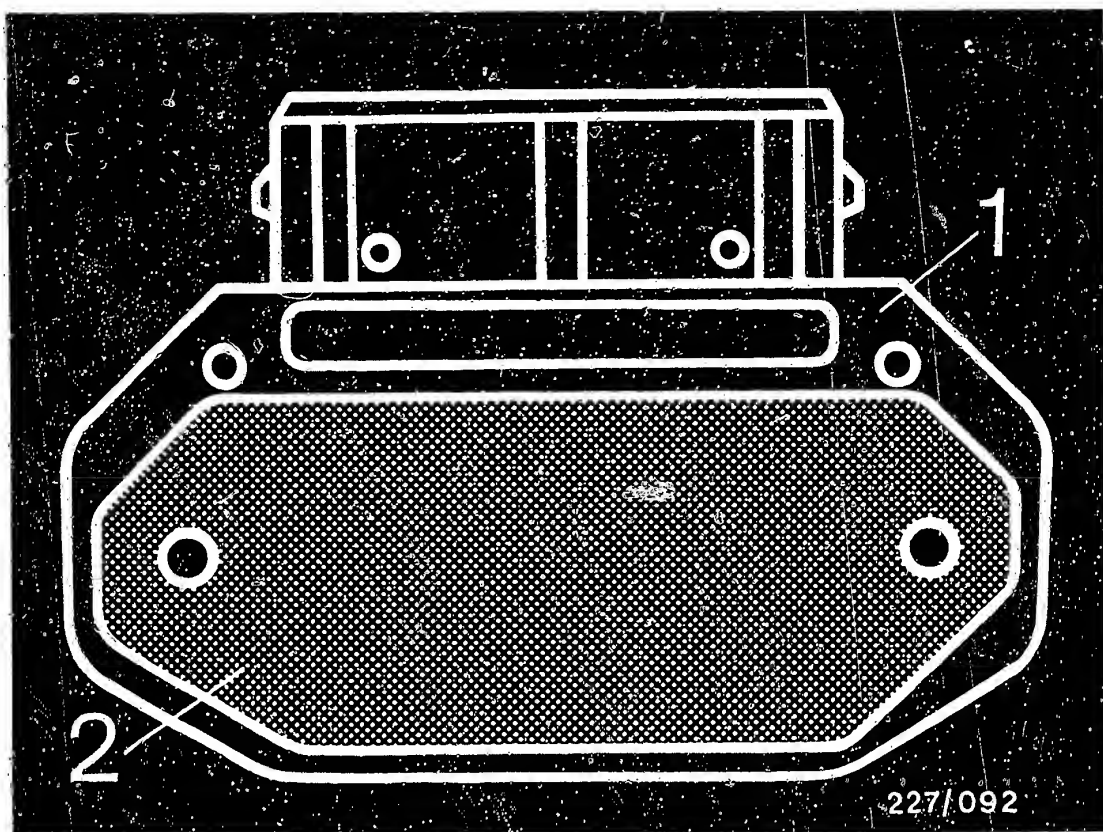
1 = Trigger box

2 = Base plate

- Before mounting the trigger box, the base plate must be coated with thermal conduction paste. Apply thermal conduction paste only with a suitable object (screwdriver, matchstick etc.)

Do not apply thermal conduction paste to painted parts.

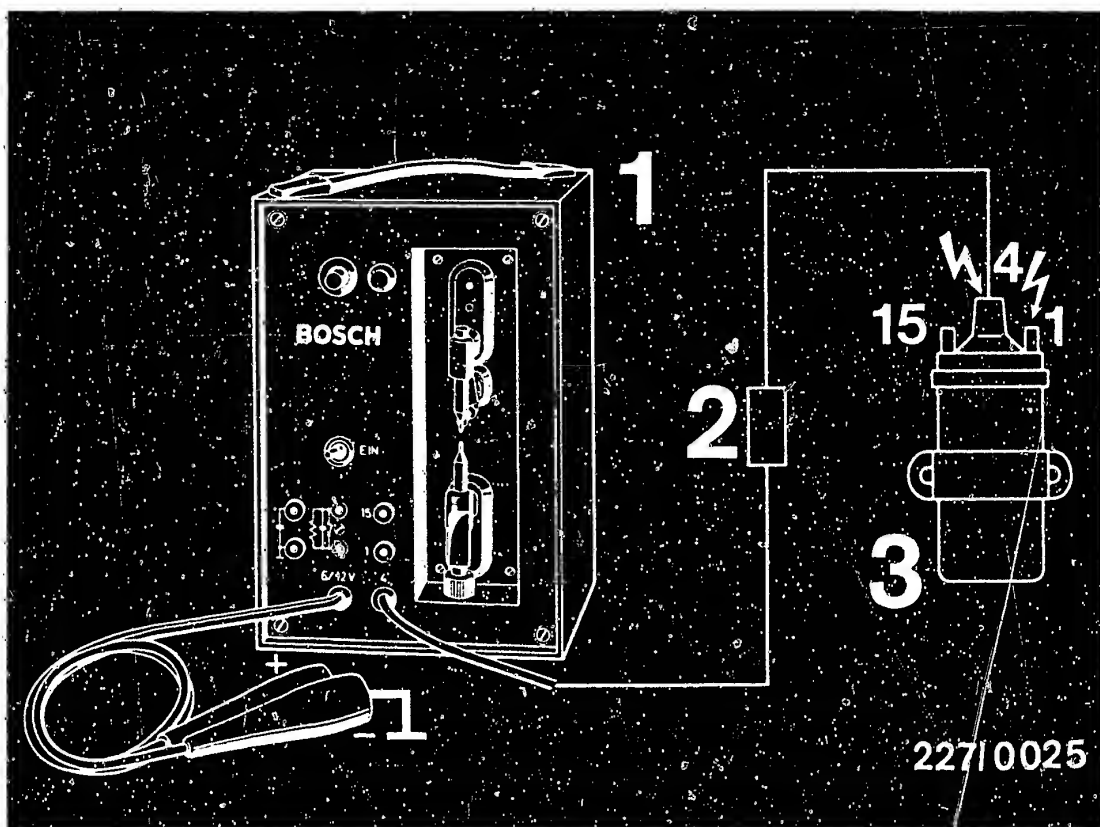
- 1 = Spark gap
- 2 = 5 k Ω sleeve-type suppressor
- 3 = Ignition coil

High-voltage arrows:
Caution, 400V...25 kV

- In order to prevent the trigger box from being irreparably damaged, when using a spark gap, an interference-suppression resistor of at least 2 k Ω must be connected between the spark gap and ignition coil terminal 4, e. g. sleeve-type suppressor (5 k Ω) 0 356 500 001.

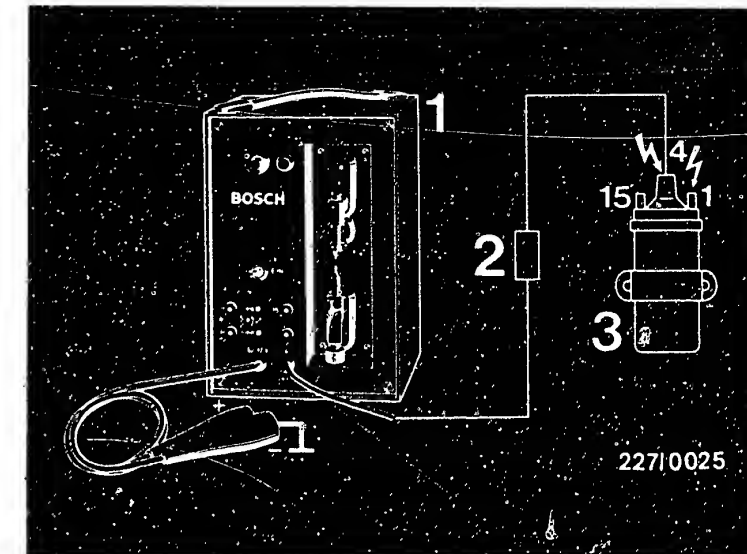
1 = Spark gap

2 = 5 k Ω sleeve-type suppressor

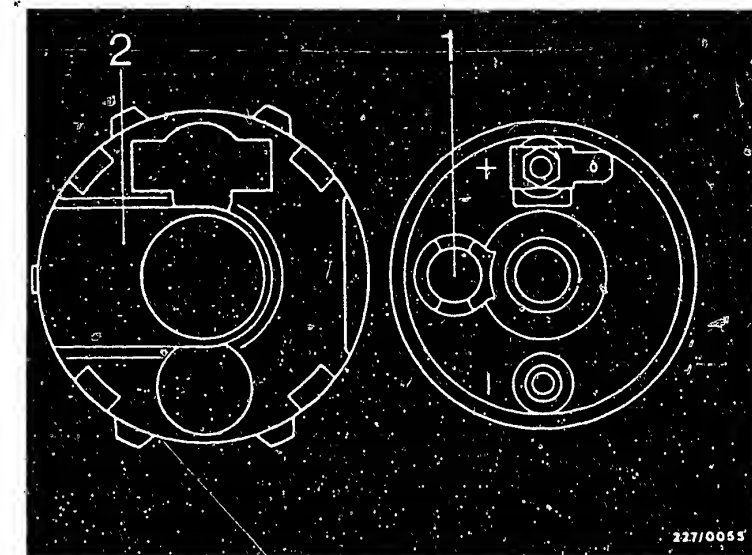
1 = Plug
2 = Protective cap

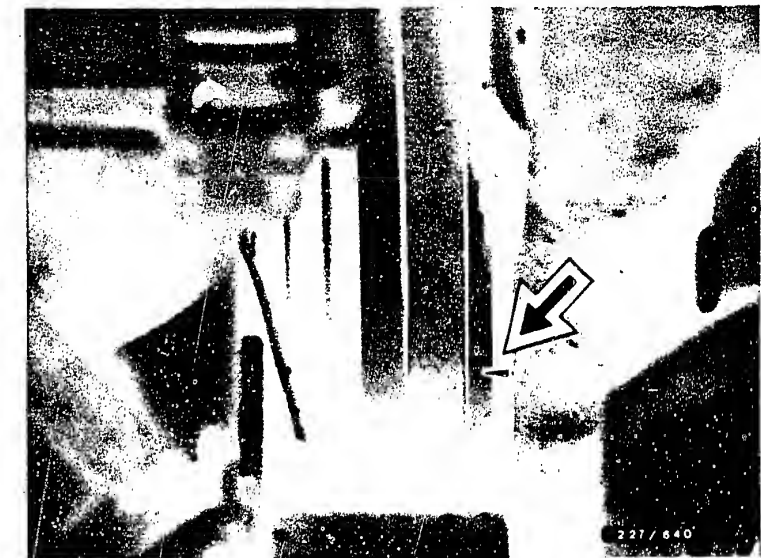
Ignition timing mark
(10° BTDC)

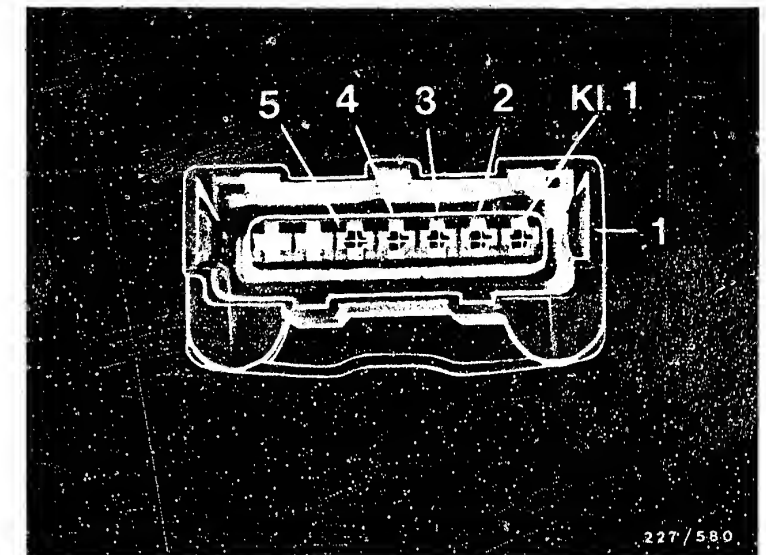
1 = Trigger box plug

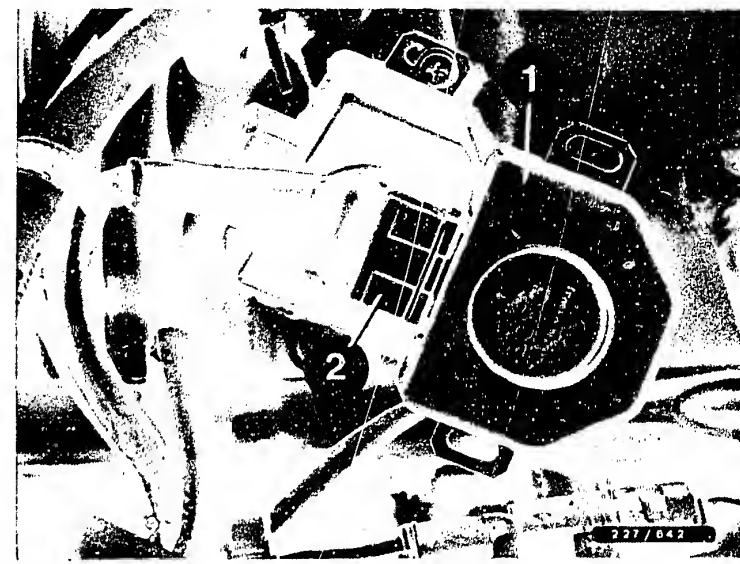
1 = Short-circuit device KDZS 0003
2 = Throttle valve switch plug

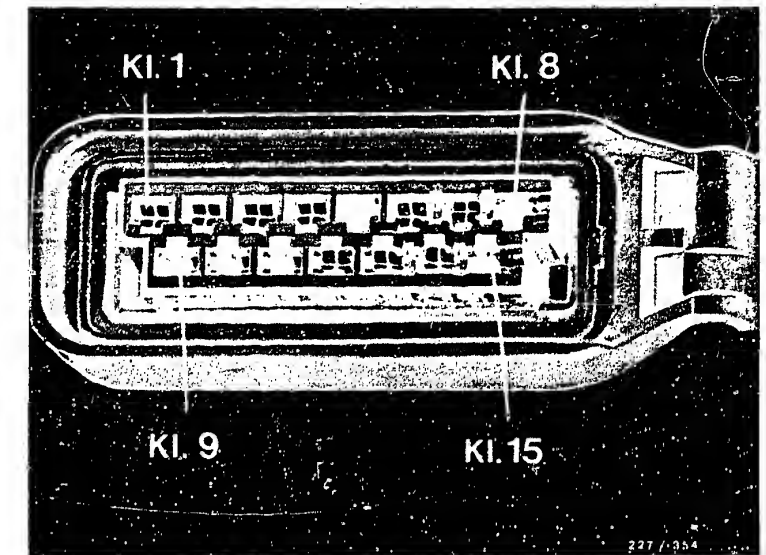
Timing advance unit plug

1 = Throttle-valve switch

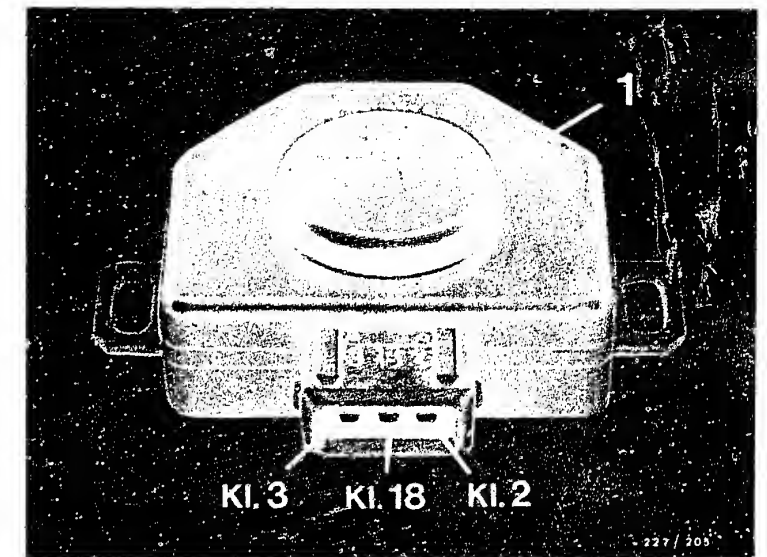
If resistance infinity (∞), replace throttle-
valve switch.

1 = Throttle-valve switch

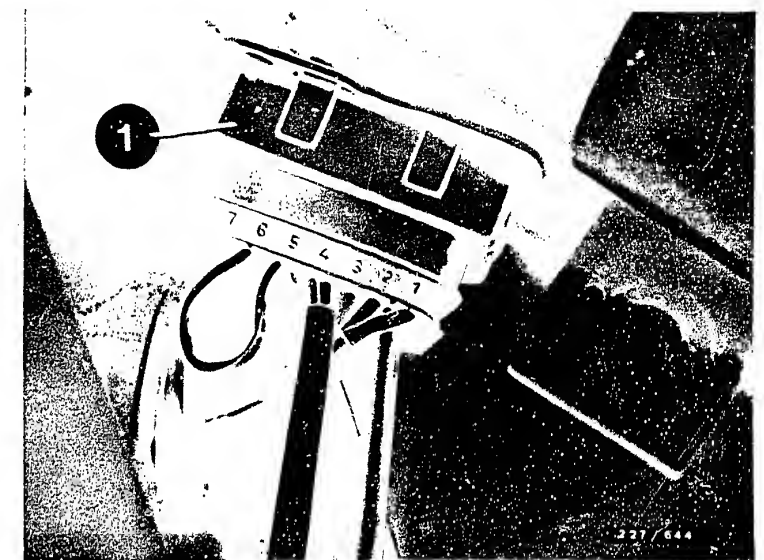
1=Trigger-box plug

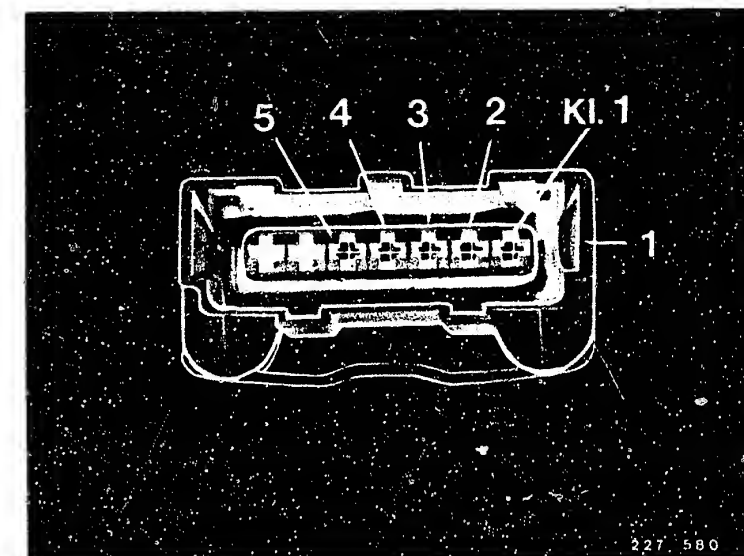
1=Trigger-box plug

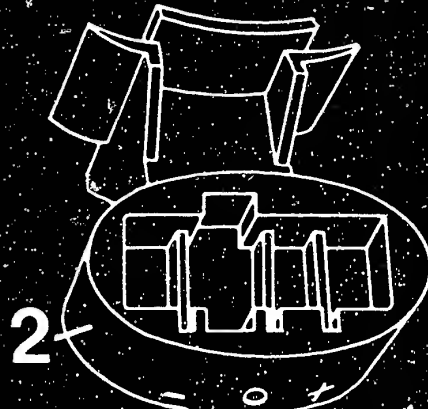
- 1 = Ignition-distributor connector
- 2 = Ignition-distributor socket

Remove the ignition-distributor connector (see picture) and check contacts for oxidation and correct latching (remedy defects).

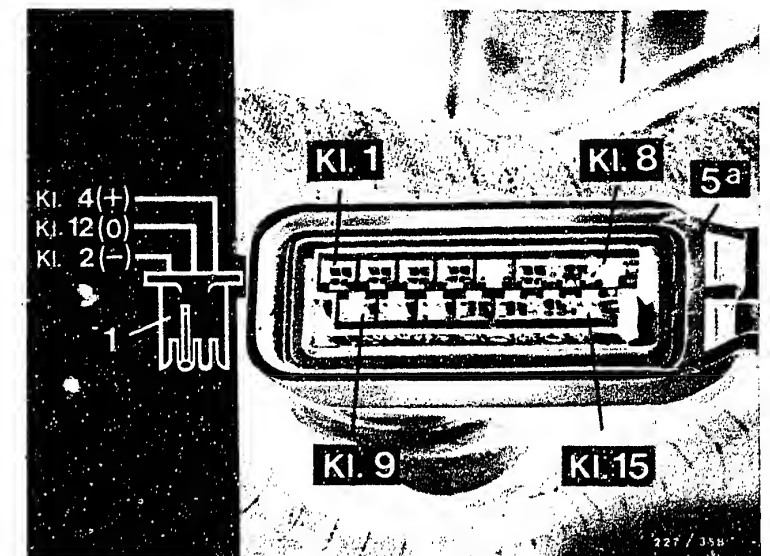
1 = Ignition-distributor connector
5a = Ignition timing unit plug

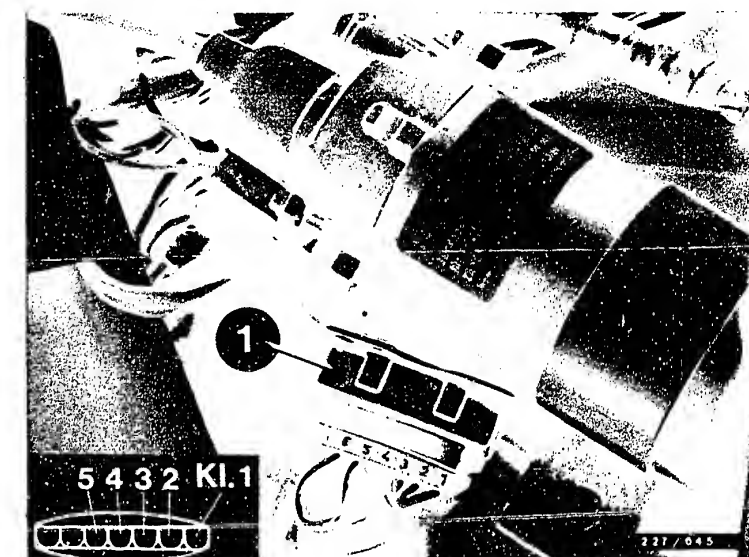
Rectangular pulse

1=Trigger-box plug

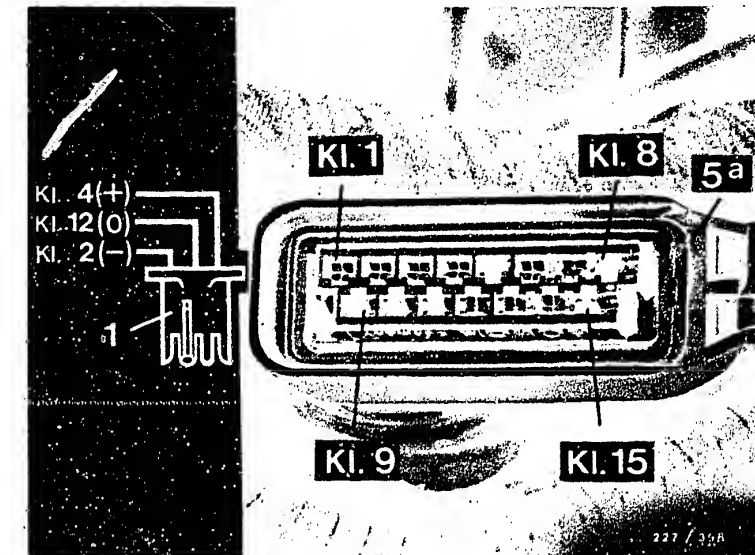
1 = Ignition-distributor connector
5a = Ignition timing unit plug

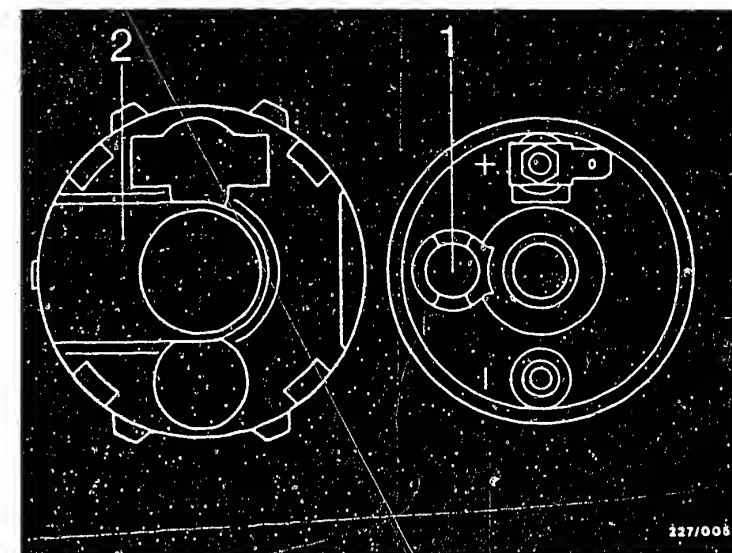
1. If plug is not in position and/or sealing compound has escaped, replace trigger-box, ignition timing unit and ignition coil.

1 = Plug
2 = Protective cap

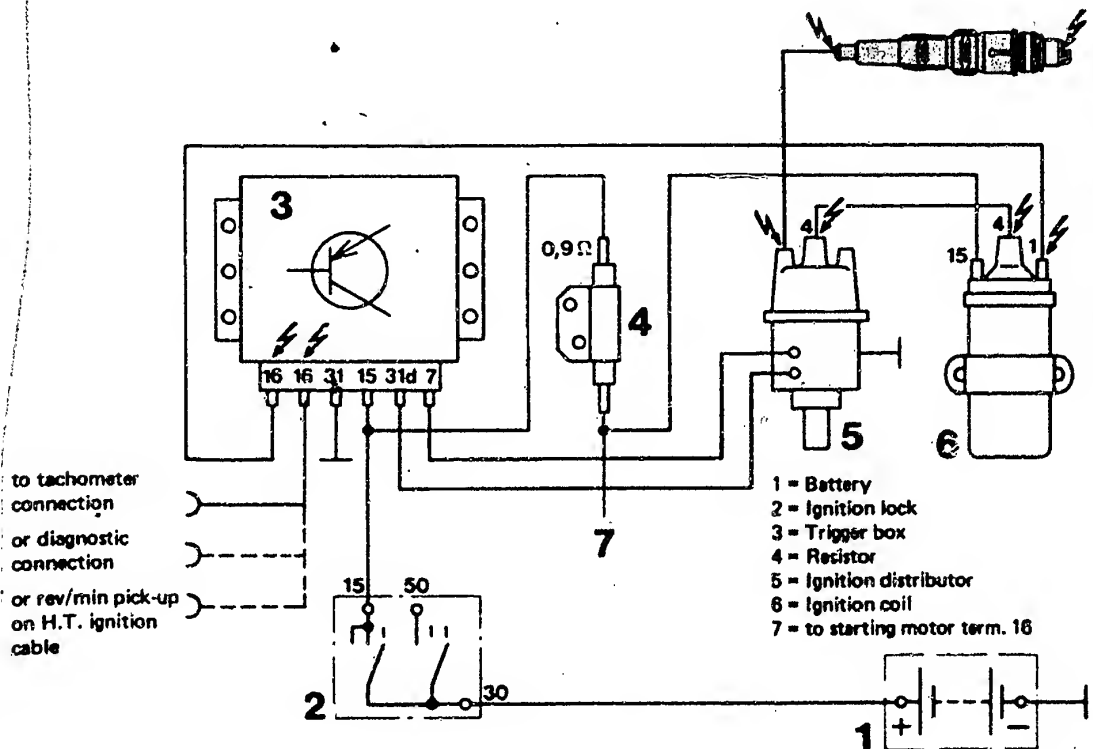
Terminal diagram

Below is a typical terminal diagram of a semi-conductor ignition system, the danger points are marked with red high-voltage arrows. We would point out that all semi-conductor ignition systems, even the older ones, are to be regarded as dangerous in the sense as defined by this bulletin.

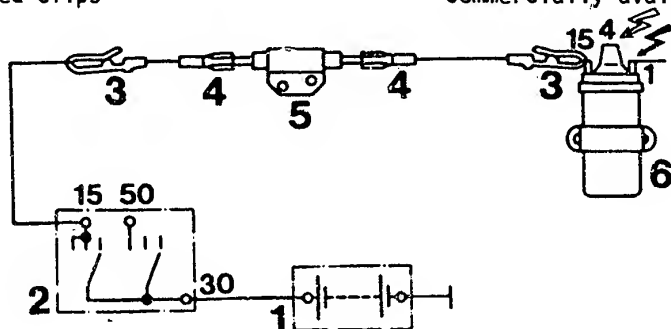
Connect a ballast resistor of 0.9 or 1.0 Ohm (see Fig.) in series in the line to term. 15 of the ignition coil (take care not to cause a short circuit). After the rotational-speed measurement, the ballast resistor must be removed (otherwise starting difficulties and misfiring). Connect tester as per operating instructions.

- 1 = Battery
- 2 = Ignition switch
- 3 = Clips

- 4 = Blade receptacle
- 5 = Ballast resistor
- 6 = Ignition coil

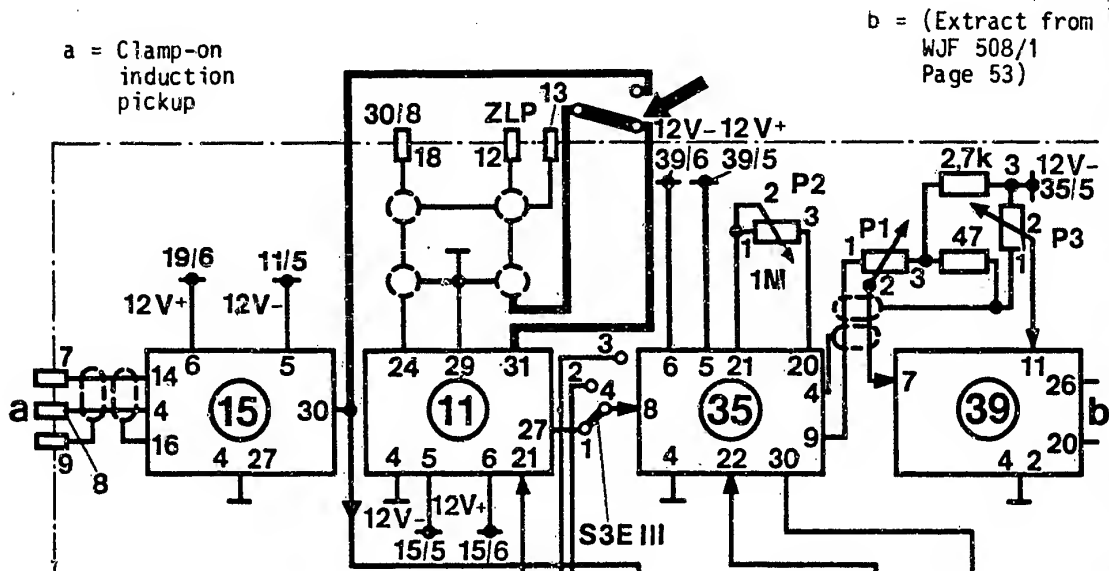
Remove the line of the ZLP* from pin 31 of printed board 11 (coupling stage) and connect to pin 30 of printed board 15 (pulse shaper stage) via a switch with change-over contact (e.g. 0 341 500 803). In addition, a new line must be connected from pin 31 of printed board 11 to the other contact of the switch with change-over contact. Arrow points to switch with change-over contact.

* ZLP = timing light

By fitting the switch with change-over contact in the front panel of the motor-tester, it is possible to switch over from standard ignition systems to those with current limitation. We recommend that the switch positions be marked correspondingly: e.g. "standard" - "current limitation".

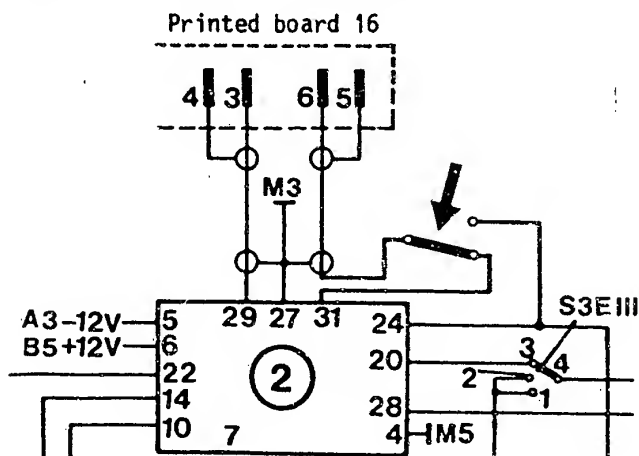
EFAW 214 B

Remove the line from terminal 6 of printed board 16 to pin 31 of printed board 2 (coupling stage) and connect to pin 24 of the same printed board via a switch with change-over contact (e.g. 0 341 500 803). In addition, a new line must be connected from pin 31 of printed board 2 to the other contact of the switch with change-over contact. Arrow points to switch with change-over contact.
